EL CERRITO STORM DRAIN MASTER PLAN

Prepared for:
THE CITY OF EL CERRITO

Prepared by:
WILLDAN ASSOCIATES
in association with
DAVID E. MATTERN, P.E.

August 1992

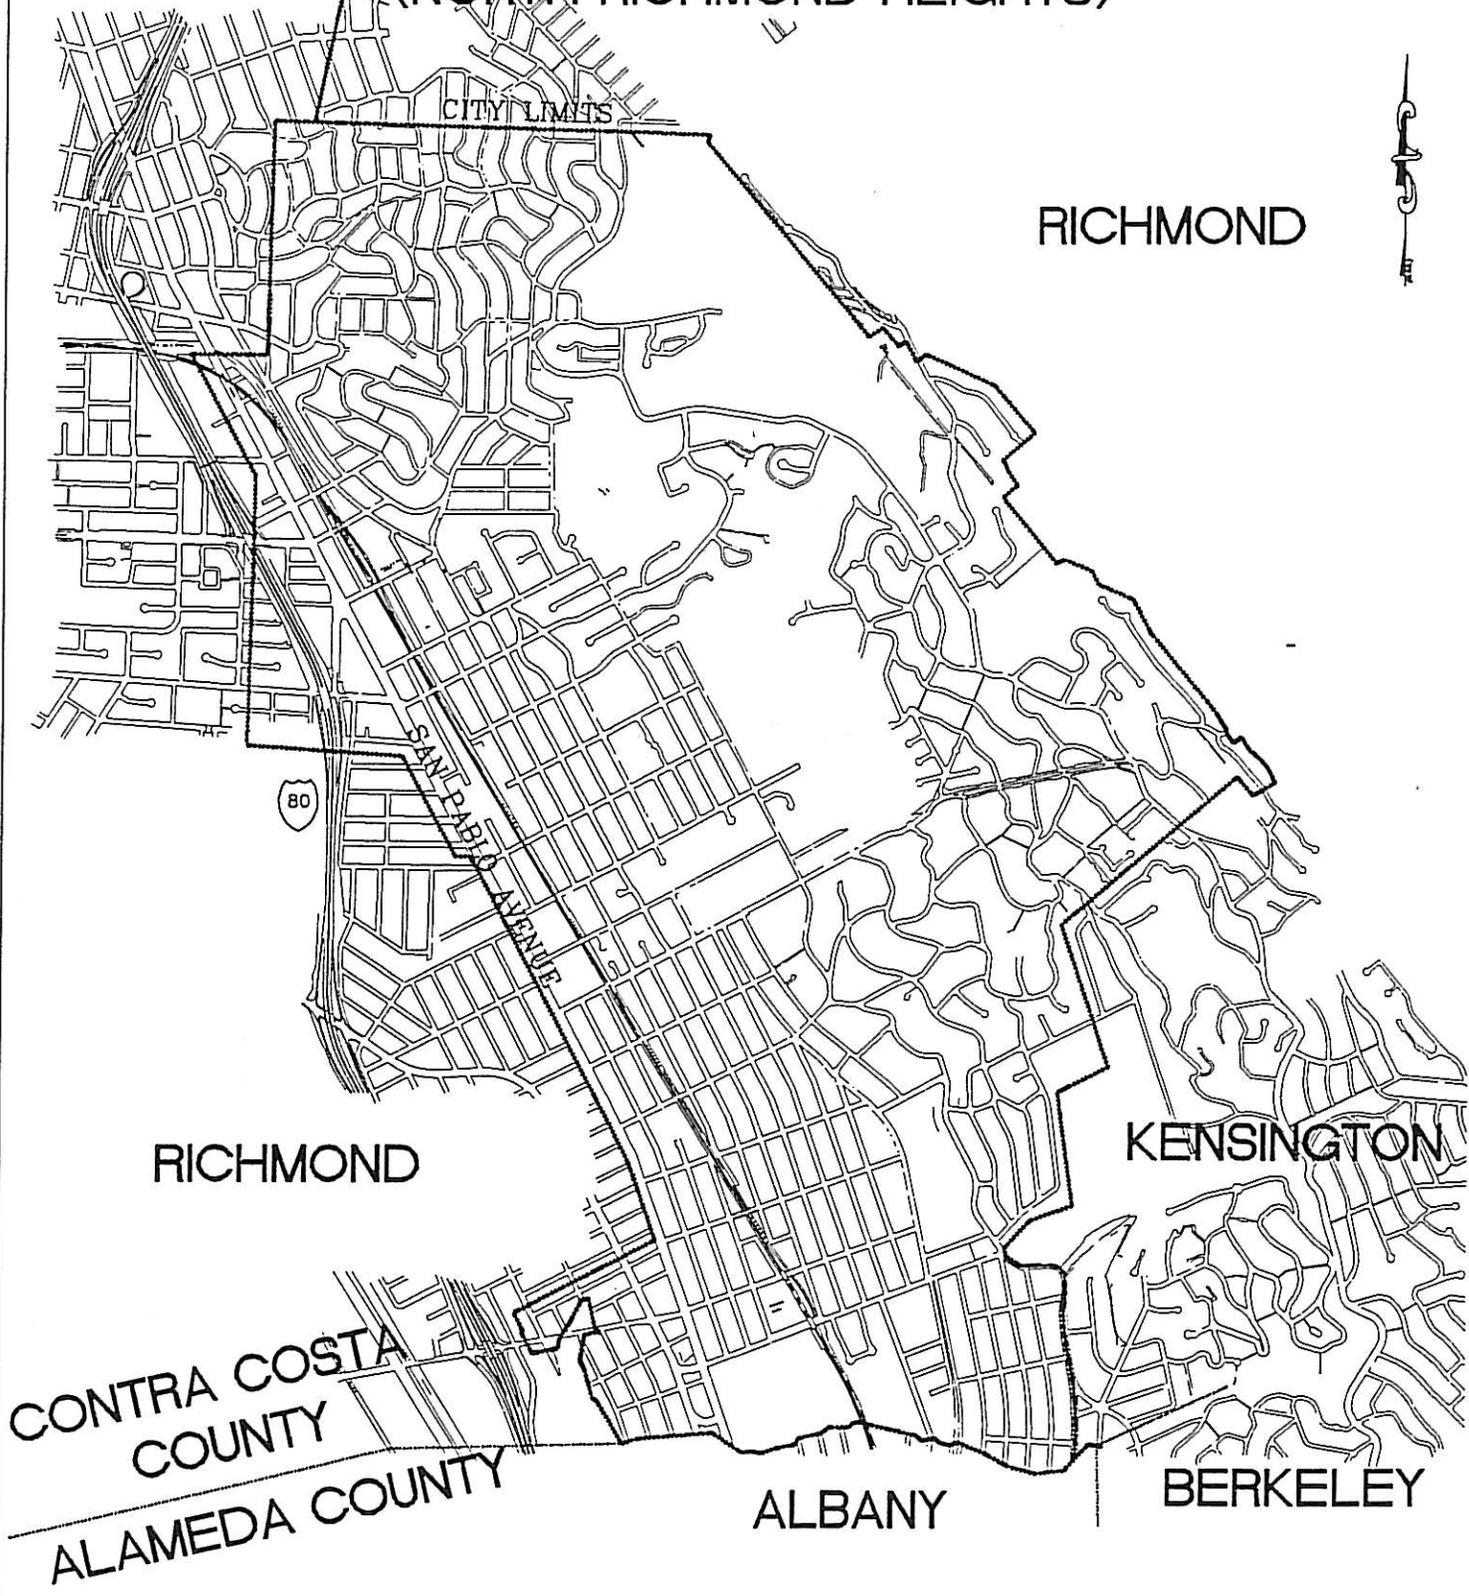
EXHIBIT B
CITY OF EL CERRITO
SITE MAP

El Cerrito is located in West Contra Costa County approximately two thirds of a mile east of the San Francisco Bay. As shown in Exhibit B, the City is bordered by the City of Richmond to the west and east, unincorporated Kensington to the southeast, unincorporated Richmond Heights to the north, and the City of Albany to the south. The City of El Cerrito is a residential community of approximately 23,000 people and covers an area of approximately 3.7 square miles. The City varies in elevation between 3 feet and 1007 feet above sea level.

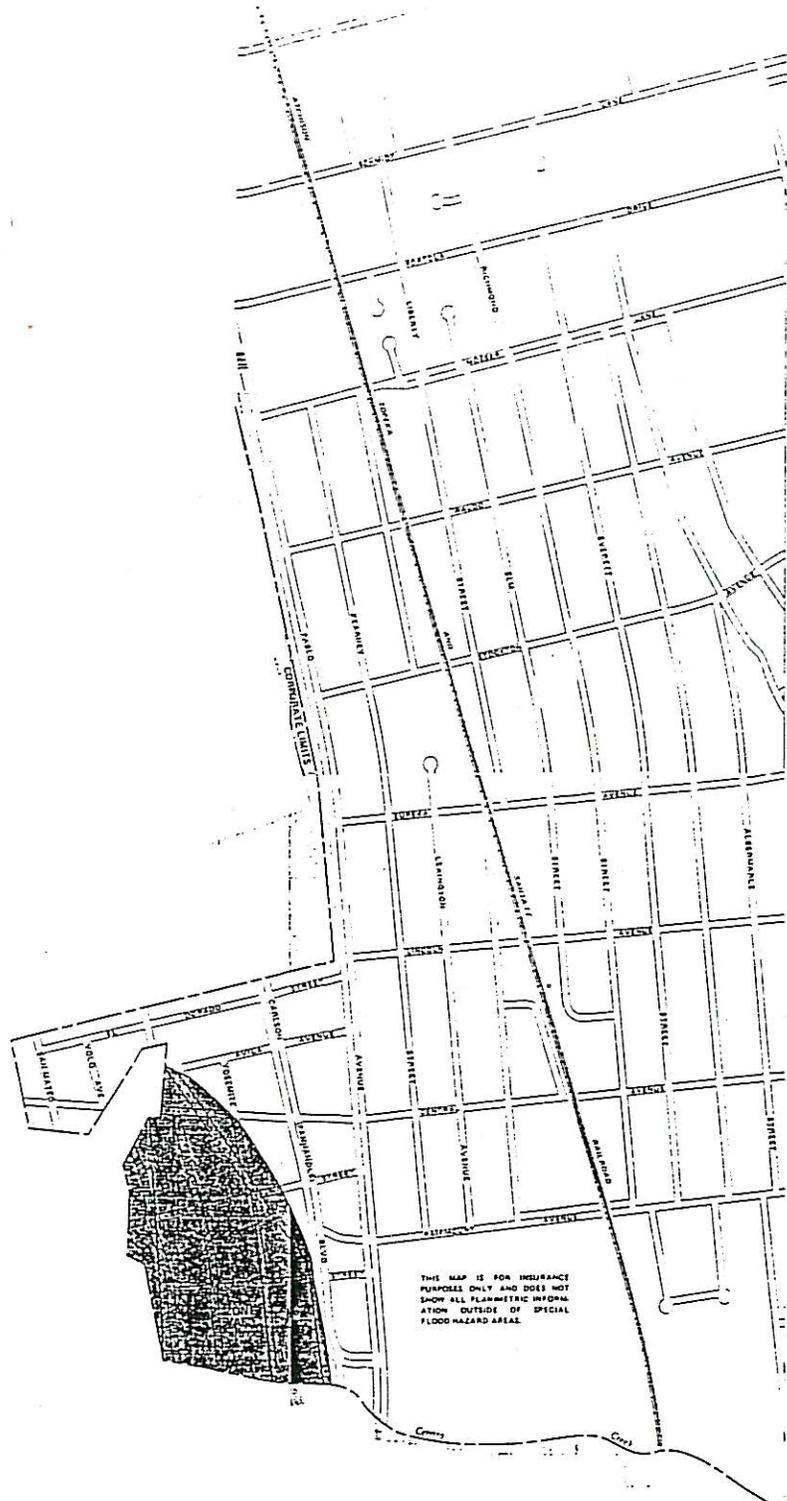
The current FEMA Flood Hazard Boundary Map for El Cerrito shows 100-year water surface elevations of 13 to 14 feet in the area west of Carlson Boulevard, as shown in Exhibit D. The flooding represents a water depth of about 6 feet at the lowest point of Belmont Avenue.

The only portion of El Cerrito located in a FEMA Flood Insurance Zone is an area called Bayview, located west of San Pablo Avenue and south of Central Avenue. Flooding is generally caused by the relatively low ground elevations in this area, coupled with hydraulic restrictions in the existing downstream channels located in Richmond between El Cerrito and the San Francisco Bay.

The lowest street elevation in El Cerrito is located on Belmont Avenue near Central Avenue and is estimated to be slightly above 7 feet, which is about 3 feet above the normal annual maximum tide level in the bay and less than one foot above the estimated 100-year tide elevation due to storms or other unusual conditions. Although maximum tide levels occurring at the same time as major storm flows, is infrequent, high tides with the existing flat channel gradients would restrict drainage in this area.

It is not certain what the exact cause of past flooding in this area has been; however, descriptions of previous flooding events indicate that some or perhaps most of the flooding resulted from overflows of the storm drain system in the San Pablo Avenue area which flow down Lassen Avenue. Additional water may have come from overflows of Cerrito Creek. During the 1969 flood, most of the homes in this area that experienced flooding were in the lowest part of Belmont Avenue between Central Avenue and San Diego Street.
